Pakuranga Rotary Shared Path

The ***Pakuranga Rotary Walkway*** is indicated on the ***Auckland Cycle Network*** map as being a completed *cycle metro* route as of 2013.

The ***Pakuranga Rotary Walkway*** is a shared path - to be used by pedestrians and cyclists.

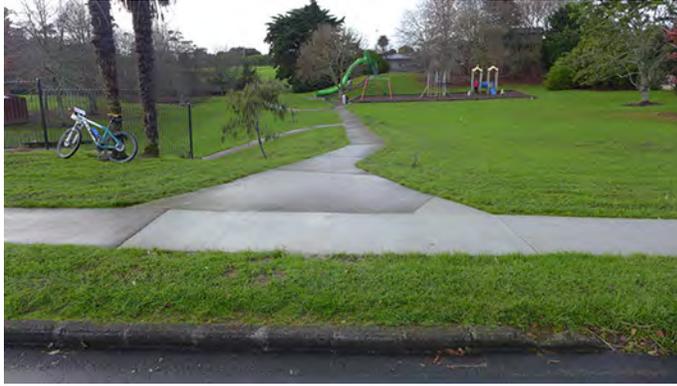
001_PRW_start spur Prince Regent Drive_1400.JPG

- 1 Start in Prince Regent Drive: no signage, no crossing from road.
- 2 into Pakuranga Domain: narrow path 1.4 m, very steep left turn
- 3 tunnel under road: 1.8 m width seems OK
- 6 intersection with Wakaaranga Creek reserve spur: narrow path, corner too sharp.
- 7 Start route from Curacao Place: no signage, no road crossing, pipe barrier.
- 8 path between walls 1.8 m wide
- 11 sharp right hand turn, path too narrow 1.4 m
- 15 path a bit low for the winter conditions
- 16 sharp right hand turn, path too narrow 1.4 m
- 20 timber boardwalk far too narrow 1.1 m

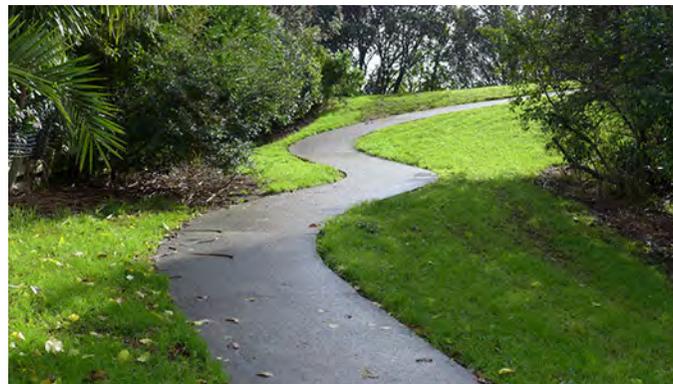
026_PRW_curvey bit_1400.JPG

- 26 path too narrow for short steep hill 1.4 m
- 27 path far too narrow for sharp turn 1.4 m
- 34 corner approaching bridge too tight
- 35 bridge 1.7 m
- 36 corner leaving bridge still too tight, extra concrete triangle helps

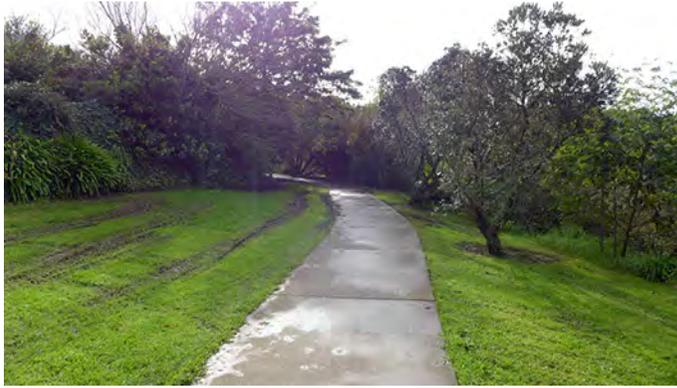
037_PRW_path_2000.JPG

- 37 at this point the path widens generally from 1.4 m to around 2 m, this is better, but most of the time still feels too narrow to be a safe and pleasant shared path.

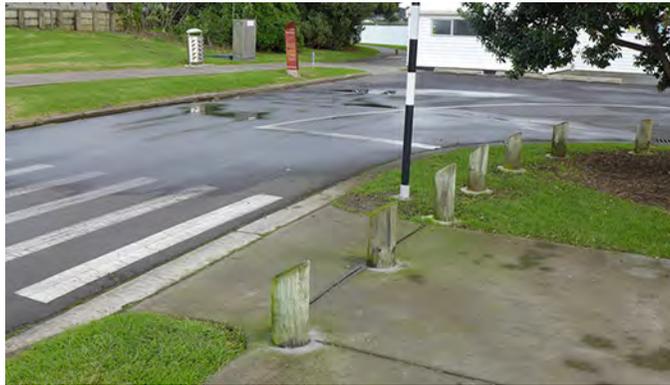
050_PRW_bollards.JPG

- 50 the termination at the end of the Eastern route at Farm Cove Reserve is not very user friendly.
- 53 similarly the start of the Western route is rather charmless.
